Technical Bulletin

Douglas Battery Terminal Connector Inspection

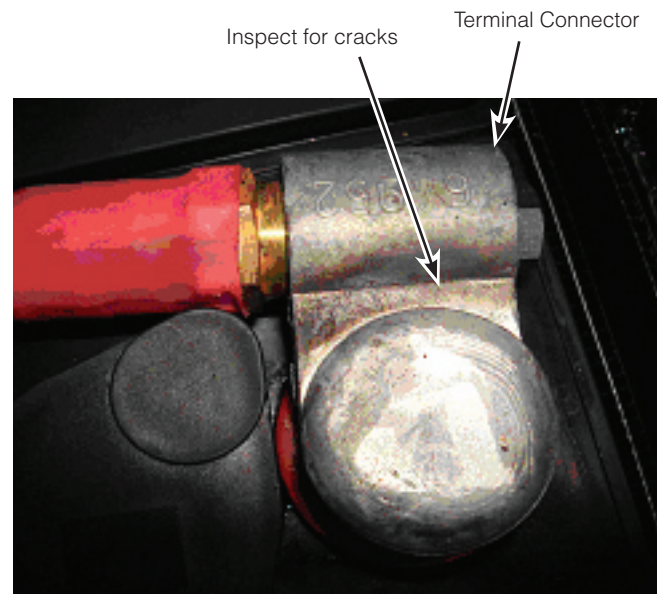
This sheet provides information for the inspection of Douglas Battery terminal connectors. We recently experienced a failure of one of the terminal connectors. A cracked terminal connector could cause the battery to overheat and catch fire. Cascade views this as a safety critical issue. Although we have only experienced one such failure, there may be others as yet undetected (see attached list of affected batteries).

- 1 Remove the plastic cover from both the negative and positive battery terminal connectors.
- 2 Inspect the terminal connectors for cracks at the flat to radius transition.
- 3 If cracks are present, notify Cascade NZ Ltd. with the information below.
